MISCELLANEOUS PAPER SL-80-15

## STRUCTURAL STABILITY EVALUATION POKEGAMA DAM

Carl E. Pace, Roy L. Campbell, G. Sam Wong

September 1980

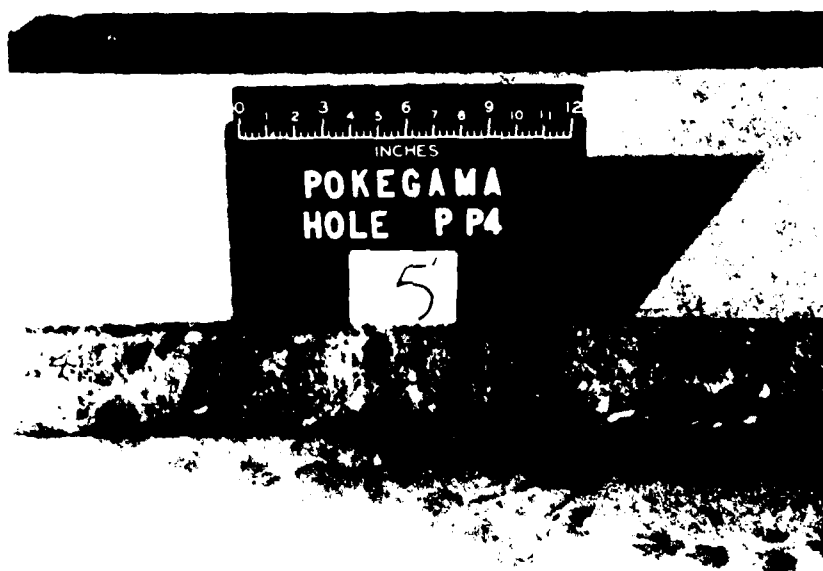
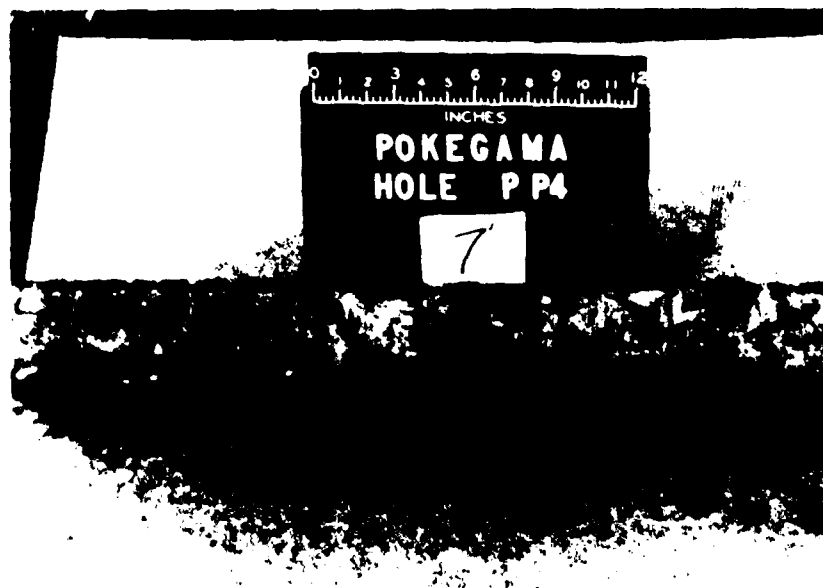
Figure 5. Core from pier 4 (P-94) (Sheet 1 of 9)

23. All of the concrete was intact; there was no evidence of frost damage or deteriorative chemical reactions even though the concrete was nonair-entrained. The upper 15 ft of concrete was different from the concrete below it (Figures 10 and 11). This upper concrete was believed to have been placed in 1903. The concrete from the upper portion of both holes contained a well graded coarse aggregate composed of 1-1/2-in. maximum size igneous and sandstone rock particles. This nonair-entrained concrete was relatively dense and hard.

27. The concrete to foundation rock contact was loose in both cores. The foundation rock was fractured near the base of the concrete. The fractures were all iron-stained joint planes.
